Typhoon H – GPS „Acquiring“-problem

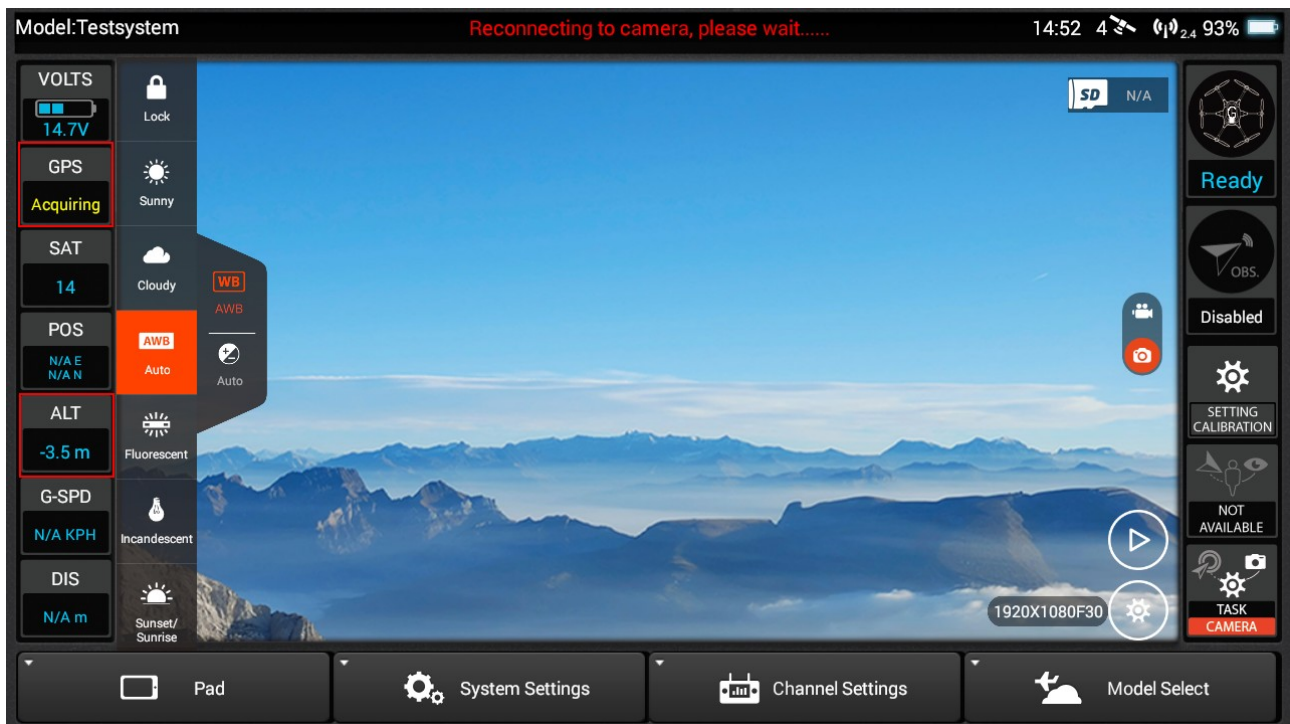
1. GPS status stuck in „Acquiring“. The drone cannot be armed anymore.
2. Motors will also not start when GPS was switched off. This unusual behavior can be used as a quick test to identify the fault.
3. Altitude on ST16 shows some meters below zero and did not initialize. The pressure sensor's height estimate is OK, near zero at this time.
4. The „Yaw“ output in the GUI is slowly rotating while sensor values from accelerometer and gyroscope are also plausible and do not change constantly in one direction as Yaw is doing.

Wrong GPS status and Altitude value:

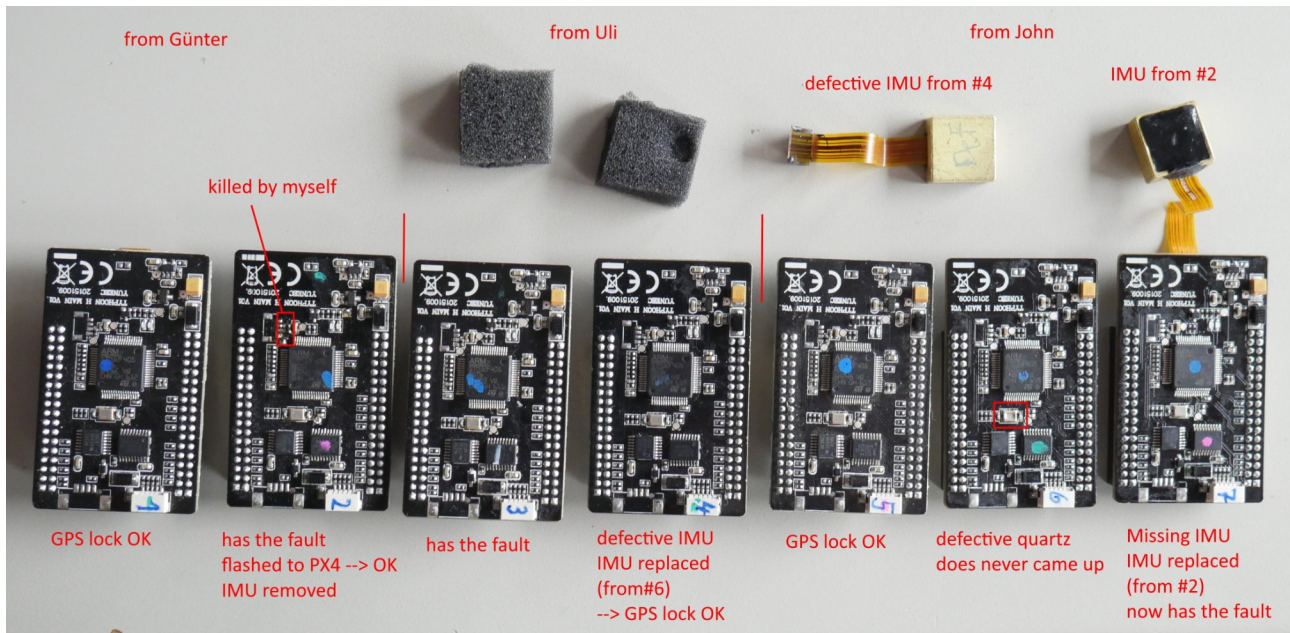
I investigated all seven MCU-boards that I got.

No 1 was fine and got GPS lock soon. It was used to compare with a good one.

No 2 had the fault with all four symptoms mentioned above. Flashing firmware back and forth did not help. Put it into the freezer and brought it down to -10°C . Now the Altitude shown on the ST16 was -15m . It came up to -4m while the board warmed up but never reached zero.

No 3 had the fault with all four symptoms mentioned above and has it still. Used for further experiments.

No 4 came with a defective IMU. Fault was reported by sound and red LED.

No 5 got GPS lock and looks OK so far.

No 6 came with mechanical destroyed quartz oscillator, does never came up.

No 7 came without IMU but came up and showed the same error indication as No 4.

At this point I decided to exchange IMU modules. MCU board No 4 got the IMU from dead board No 6. As result it came up and got GPS lock. This board looks good now.

Then I replaced the IMU on MCU No7 with the one from No2. Now the fault with all four typically symptoms was moved to this MCU board. It looks like the problems travels with the IMU module. To verify this I have exchanged the IMU with the one from No 4. Now it got GPS lock and works. Change back brings the fault back.

I'm pretty sure that **the IMU is the reason for the faulty behavior**. I think there is a charge of IMU modules that aging and run out of some threshold in the firmware. As result the EKF output for altitude and NED orientation is implausible and the pre-flight check fails.

- In rare cases GPS lock came after very long time (~4h) and faster at next try.
- Sometimes it helps to downgrade the flight controller firmware. Not in all cases an upgrade to latest firmware is successful after that, but sometimes this is possible.
- **The ultimate solution is to replace the flight controller module (MCU-board).**

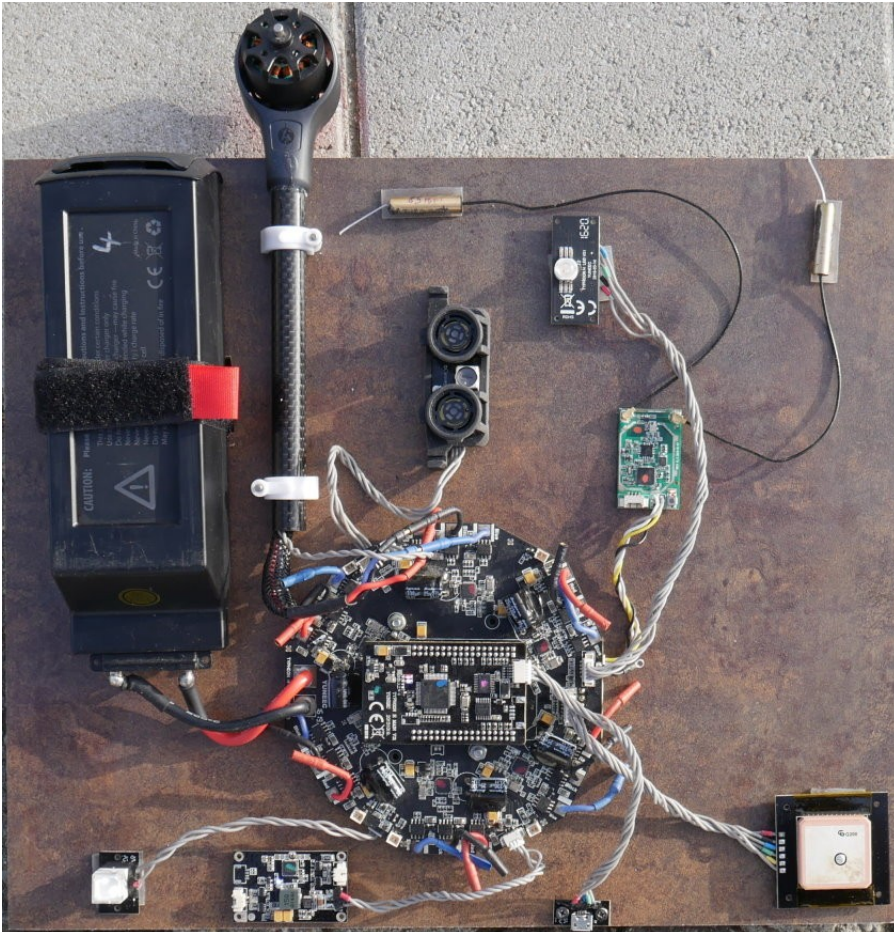
The “good-ones” are only checked in the test system.

I never did a compass calibration with the board except the Thunderbird. Flight test are still pending to make sure it could be used in a drone.
