# **Typhoon H – GPS "Acquiring"-problem**

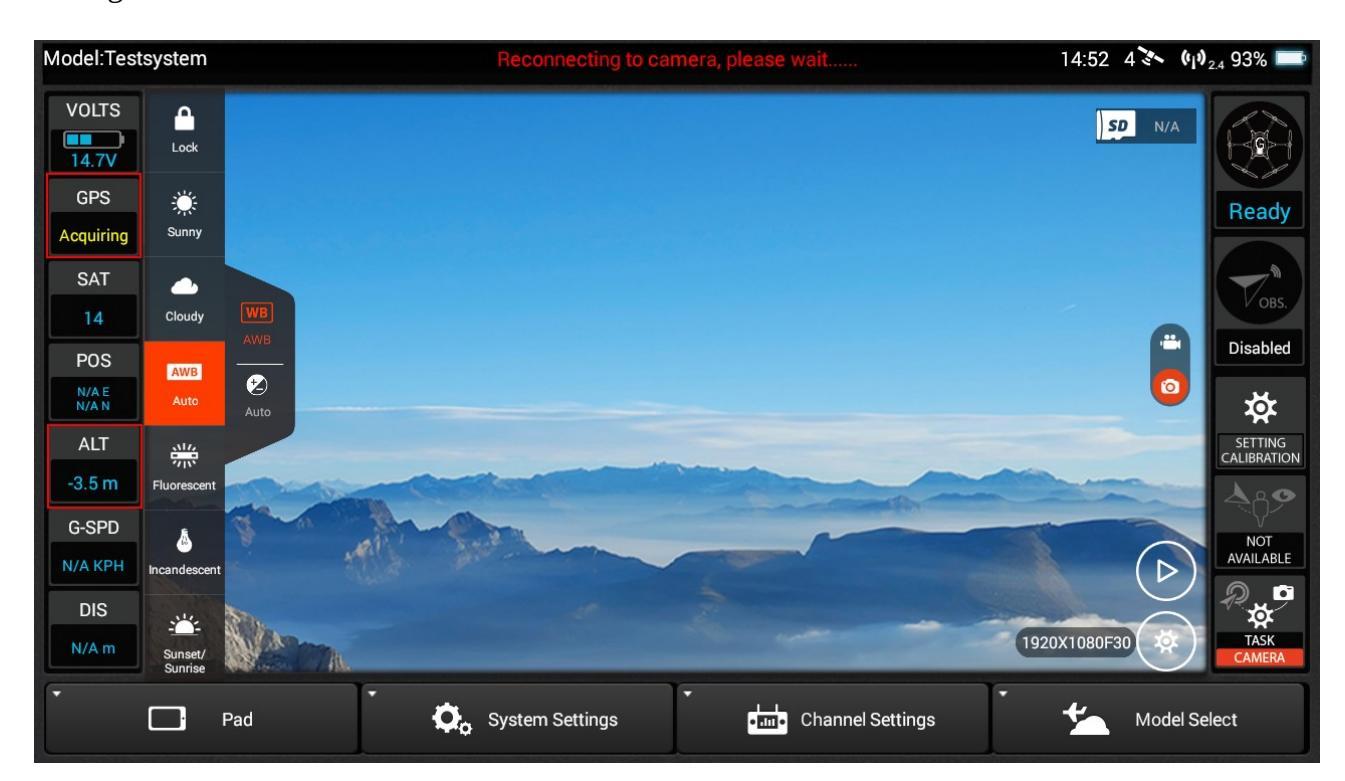
- 1. GPS status stuck in "Acquiring". The drone cannot be armed anymore.
- 2. Motors will also not start when GPS was switched off. This unusual behavior can be used as quick test to identify the fault.
- 3. Altitude on ST16 shows some meters below zero and did not initialize. The pressure sensor's height estimate is OK, near zero at this time.
- 4. The "Yaw" output in the GUI is slowly rotating while sensor values from accelerometer and gyroscope do not change constantly in one direction as Yaw is doing.
- 5. Accelerometer Z-axis has a value far below 1000mG. This is wrong because we have 1G on earth. This indicates the root cause of the problem: ACCEL\_ZOUT of MPU < 1000mG.

Wrong GPS status and Altitude value:

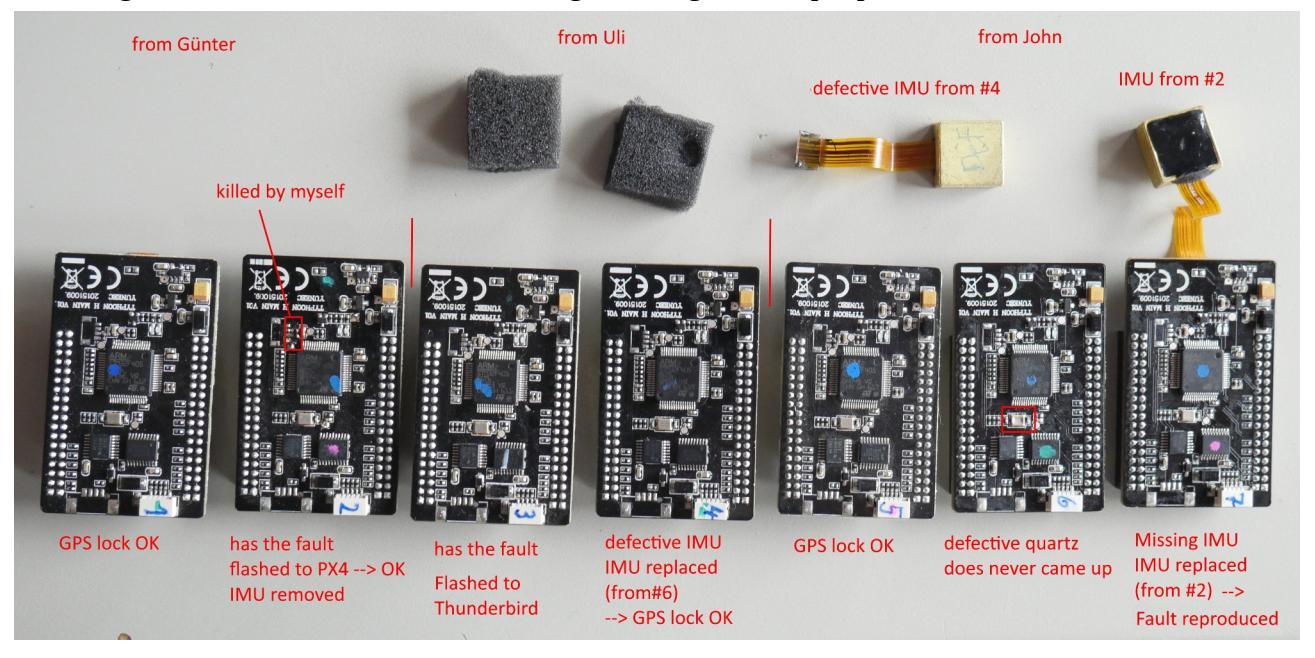
I investigated all seven MCU-boards that I got from generous people.

No 1 was fine and got GPS lock soon. It was used to compare the others with a good one.

No 2 had the fault with all four symptoms mentioned above. Flashing firmware back and forth did not help. Put it into the freezer and brought it down to -10°C. Now the Altitude shown on the ST16 was -15m. It came up to -4m while the board warmed up but never reached zero. Now the board was flashed with customized PX4 autopilot (Thunderbird firmware from Toni Rosendahl). It cames up, could be connected to QGroundControl. After proper calibration it could be armed and all looks plausible. Due to poor test system not flight test was possible. But during soldering on the board I have destroyed a pull-up resistor. So, this board is crap now.

No 3 had the fault with all four symptoms mentioned above and has it still. Used for further experiments.

No 4 came with a defective IMU. Fault was reported by sound and red LED.

No 5 got GPS lock and looks OK so far.

No 6 came with mechanical destroyed quartz oscillator, does never came up.

No 7 came without IMU but came up and showed the same error indication as No 4.

At this point I decided to exchange IMU modules. MCU board No 4 got the IMU from dead board No 6. As result it came up and got GPS lock. This board looks good now.

Then I replaced the IMU on MCU No7 with the one from No2. Now the fault with all four typically symptoms was moved to this MCU board. It looks like the problems travels with the IMU module. To verify this I have exchanged the IMU with the one from No 4. Now it got GPS lock and works. Change back brings the fault back.

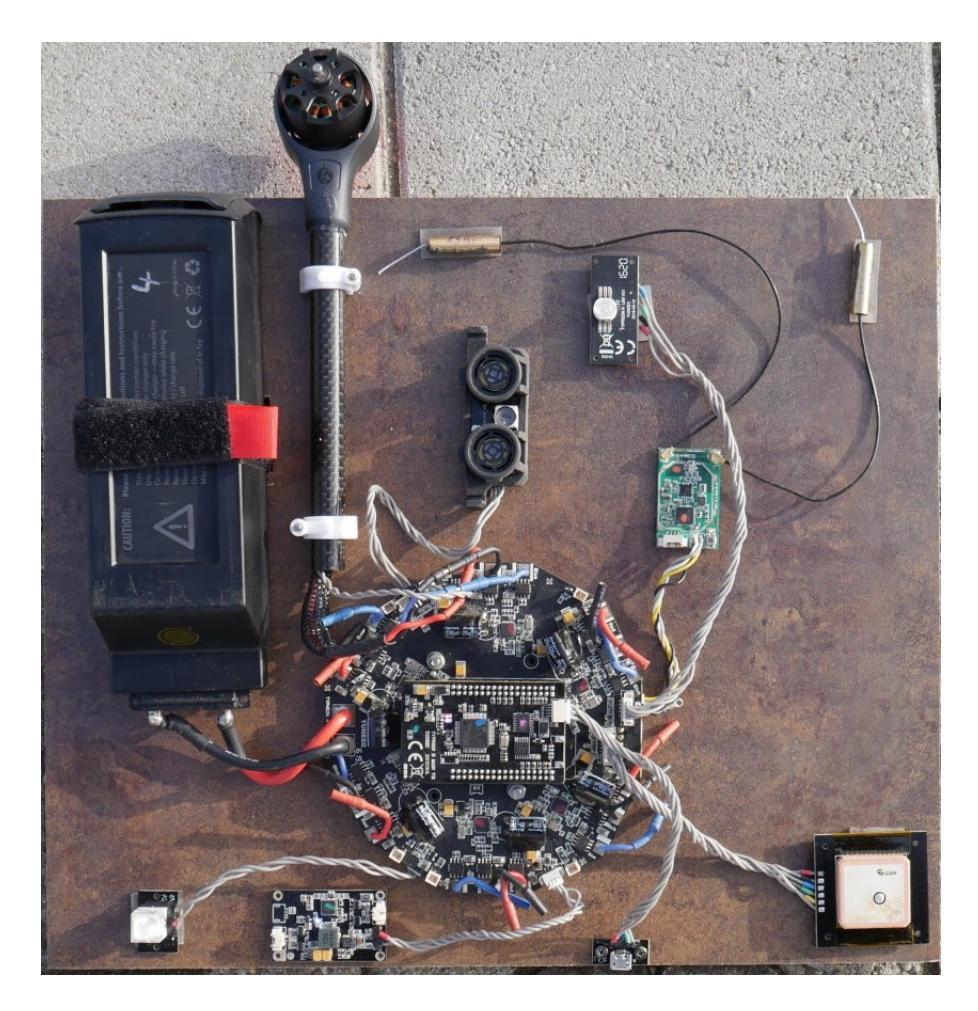
In some cases the problem could overcome by downgrade the flight controller firmware to an old version. For the MCU-boards where I could reproduce the fault this didn't work.

I never did a compass calibration with the board except the Thunderbird. Flight test are still pending to make sure it could be used in a drone.

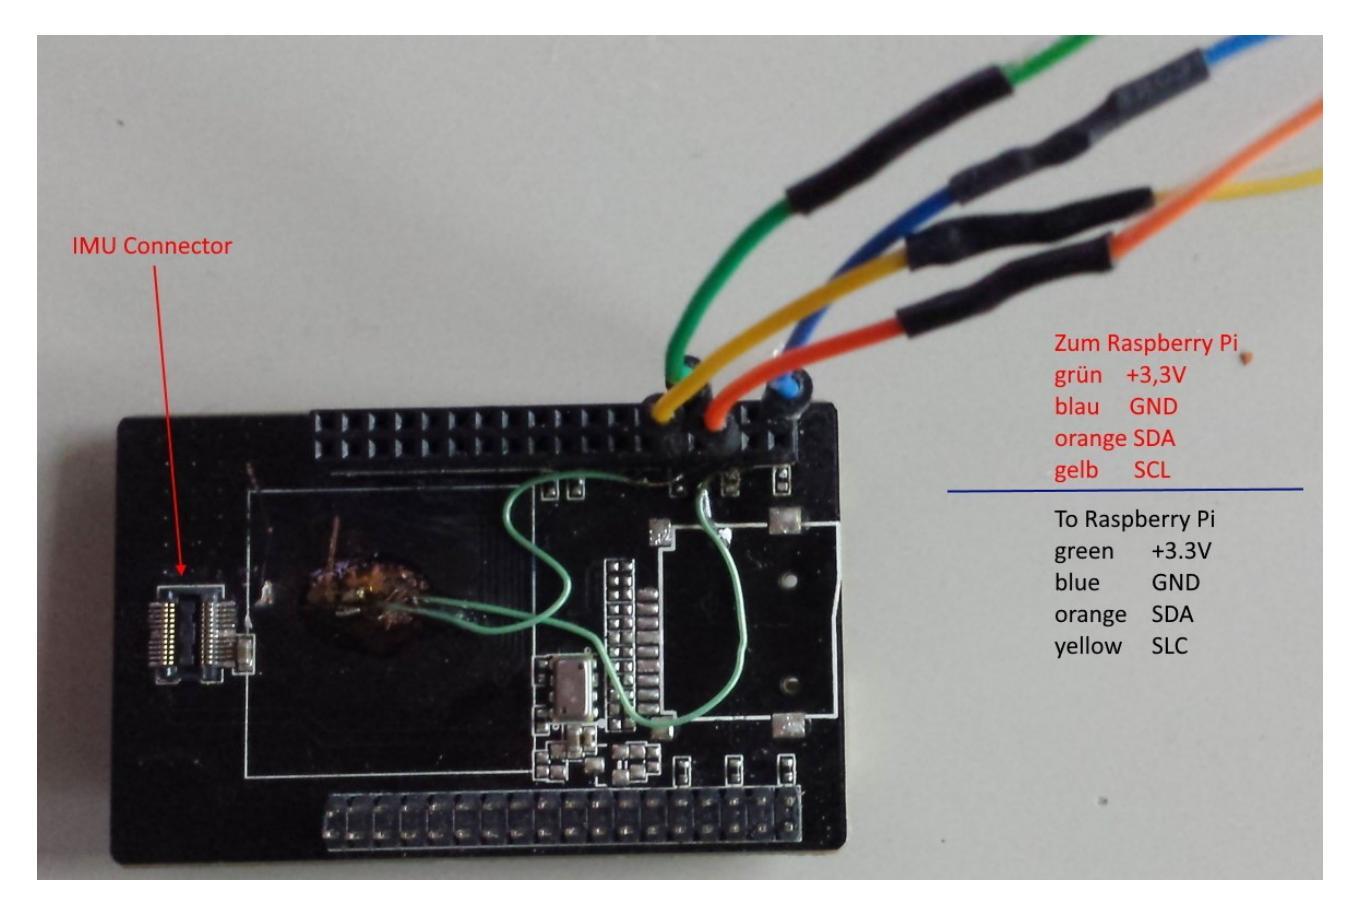
I have made an adapter for the tiny IMU connector in order to connect the IMU module to another device, in my case a Raspberry Pi.

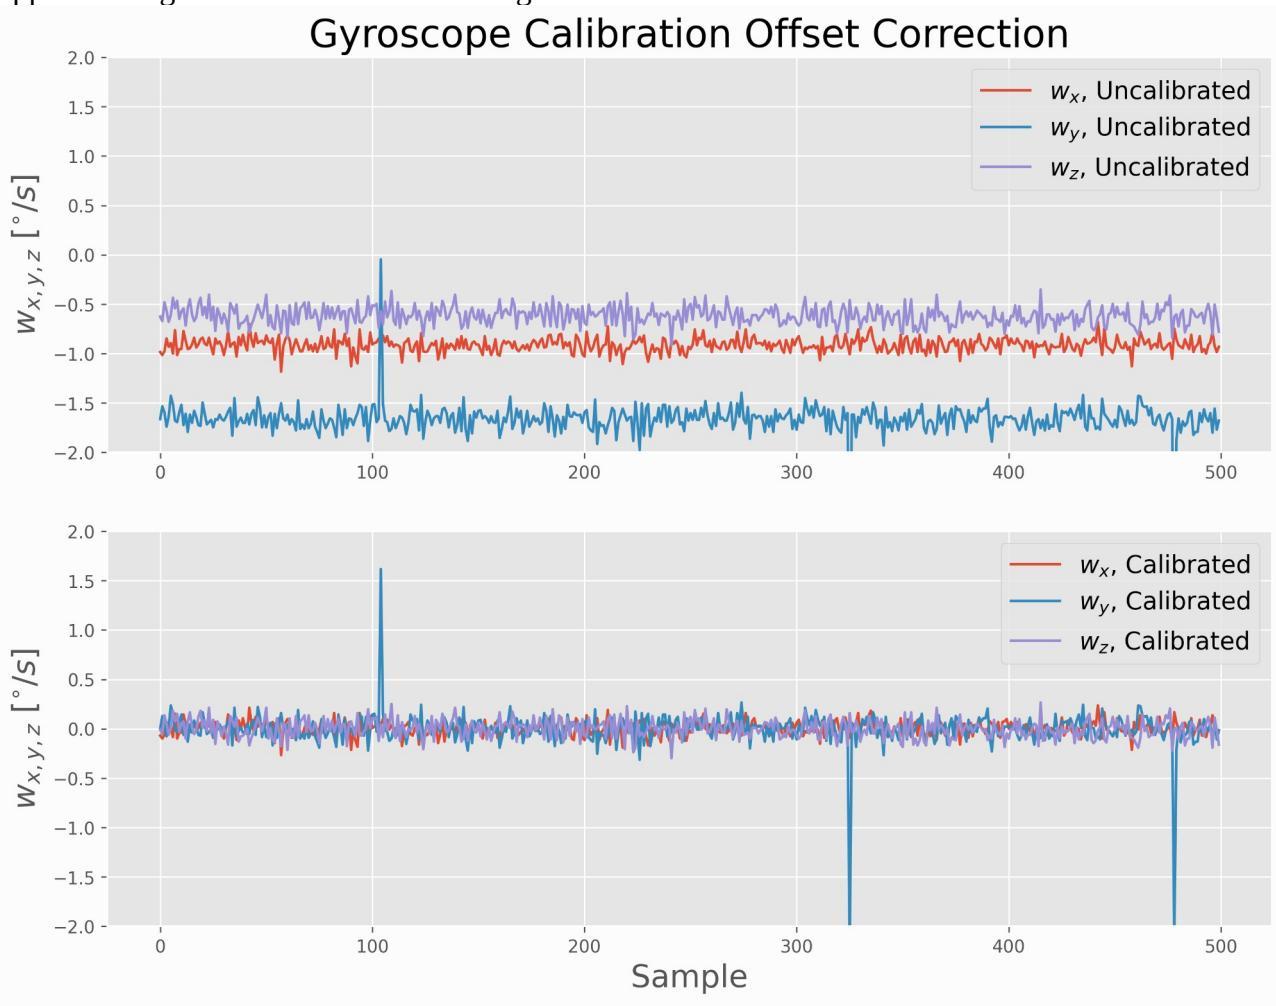
At the calibration result from Flight Controlles IMU, I wonder what those spikes mean which appear during calibration without moving the IMU.
